**Flood Control Project Maintenance  
Levee Inspections**  
**LMA District Cover Sheet**  
**Spring 2020 Levee Inspection Results**

**Reclamation District No. 2104 Peters Pocket Tract**

**Levee Inspection Report By Mile - Spring 2020**

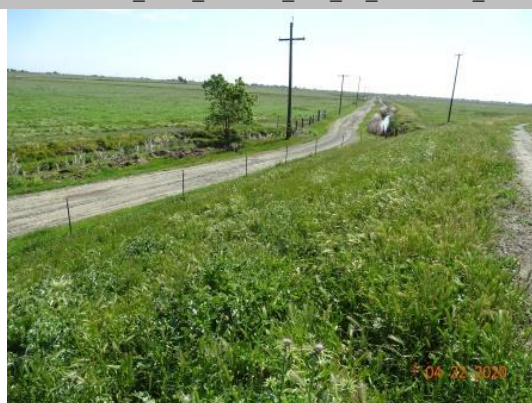
Photo 1 of 1 : SP\_2020\_RD2104\_249\_27\_20200423\_00052.jpg

LM Start	0.88	Rating **	M	Issue No.	27
LM End	1.42	Issue Type +	Ma	Location *	LS
Category	Earthen Levee			GPS Latitude/Longitude	
				Start	End
Item	Vegetation			38.299369 °	38.295686 °
				-121.749861 °	-121.741800 °
DWR ID	DWR_RD2104_01_f_2019_27				
Comment Code					
V1 : Control annual grass and weeds on the levee slopes and easements.					
Inspector Comment

View looking downstream at annual vegetation on the landside slope (Spring 2020).

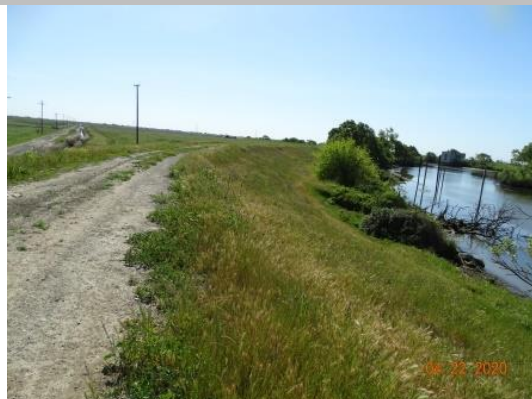
Photo 1 of 1 : SP\_2020\_RD2104\_249\_28\_20200423\_00053.jpg

LM Start	0.88	Rating **	M	Issue No.	28
LM End	1.42	Issue Type +	Ma	Location *	WS
Category	Earthen Levee			GPS Latitude/Longitude	
				Start	End
Item	Vegetation			38.299368 °	38.295686 °
				-121.749860 °	-121.741800 °
DWR ID	DWR_RD2104_01_f_2019_28				
Comment Code					
V1 : Control annual grass and weeds on the levee slopes and easements.					
Inspector Comment

View looking downstream at annual vegetation on the waterside slope (Spring 2020).

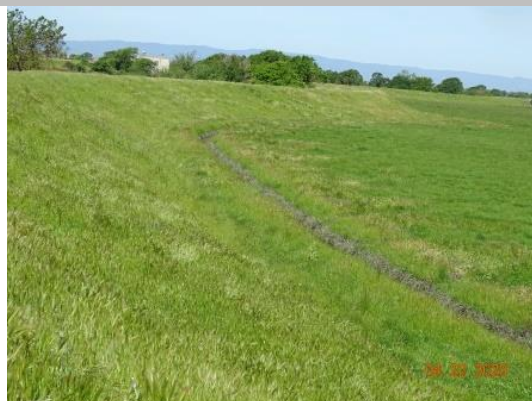
Photo 1 of 1 : SP\_2020\_RD2104\_249\_19\_20200423\_00054.jpg

LM Start	0.88	Rating **	M	Issue No.	19
LM End	1.38	Issue Type +	En	Location *	LS
Category	Earthen Levee			GPS Latitude/Longitude	
				Start	End
Item	Encroachments			38.299338 °	38.295697 °
				-121.749839 °	-121.742535 °
DWR ID	DWR_RD2104_01_s_2020_19				
Comment Code					
DT : Ditch					
Inspector Comment					
Ditch is within 15 feet of landside toe.

View looking upstream at ditch on the landside toe (Spring 2020).

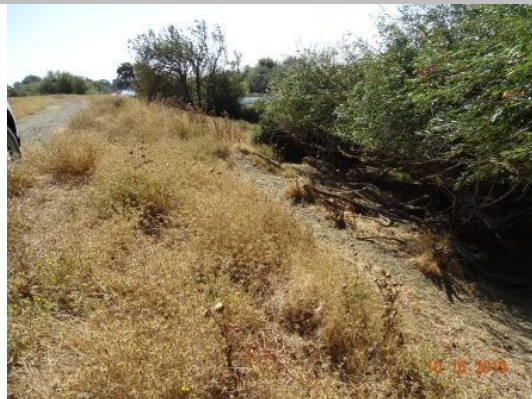
Photo 1 of 1 : SP\_2020\_RD2104\_249\_23\_20200304\_00005.jpg

LM Start	1.27	Rating **	M	Issue No.	23
LM End	1.27	Issue Type +	Ma	Location *	WS
Category	Earthen Levee			GPS Latitude/Longitude	
				Start	End
Item	Animal Control			38.296182 °	38.296182 °
				-121.744318 °	-121.744318 °
DWR ID	DWR_RD2104_01_f_2016_23				
Comment Code					
A2 : Repair the levee slope damaged by livestock and prevent large animal access.					
Inspector Comment					
Repair the slope damaged by cows.

View looking downstream at trail caused by cows on the waterside slope (Fall 2019).

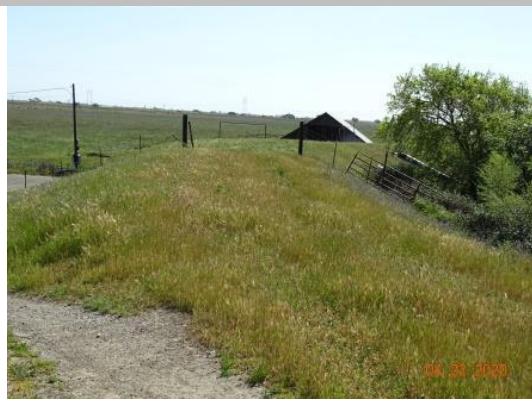
Photo 1 of 1 : SP\_2020\_RD2104\_249\_25\_20200423\_00055.jpg

LM Start	1.38	Rating **	M	Issue No.	25
LM End	6.52	Issue Type +	Ma	Location *	CR
Category	Earthen Levee			GPS Latitude/Longitude	
				Start	End
Item	Vegetation			38.295688 °	38.312976 °
				-121.742466 °	-121.758142 °
DWR ID	DWR_RD2104_01_s_2020_25				
Comment Code					
V9 : Keep the crown roadway free of vegetation.					
Inspector Comment

View of vegetation on the crown (Spring 2020).

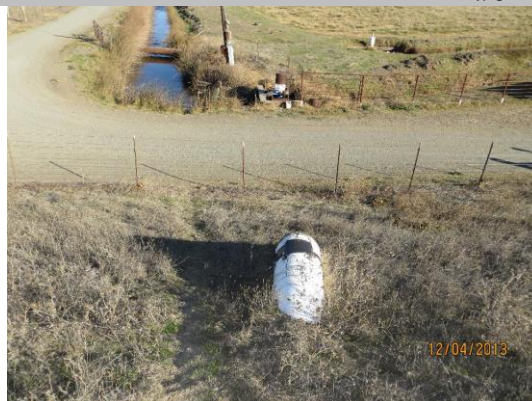
Photo 1 of 3 : UCIP\_SP\_2020\_24984\_45042.jpg

Pipe on LS slope with pump in irrigation ditch off LS toe visible in background.

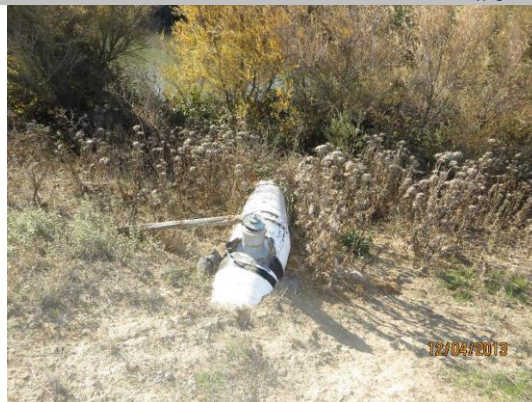
Photo 2 of 3 : UCIP\_SP\_2020\_24984\_45041.jpg

Siphon breaker on pipe at WS slope.

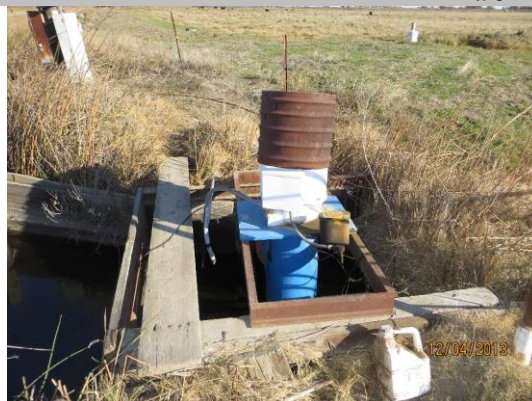
Photo 3 of 3 : UCIP\_SP\_2020\_24984\_45040.jpg

Pump in wooden distribution box off LS toe.

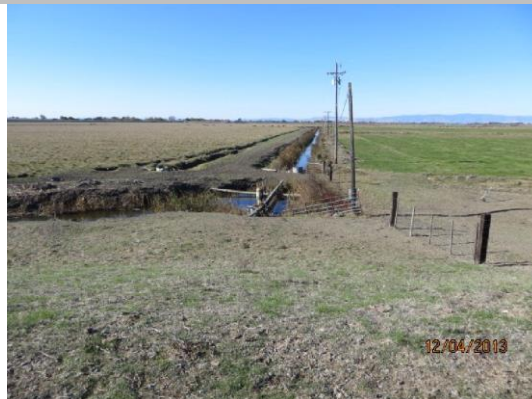
Photo 2 of 2 : UCIP\_SP\_2020\_24990\_45046.jpg

Pump on pier in ditch off LS toe.

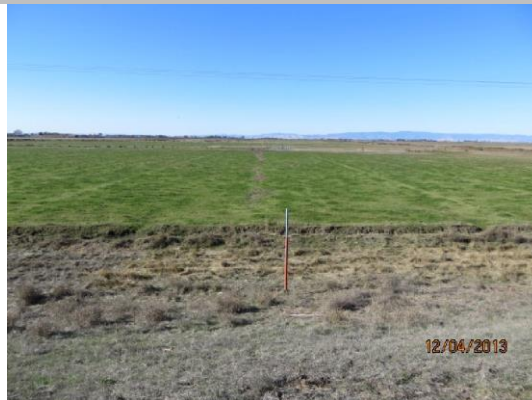
Photo 2 of 3 : UCIP\_SP\_2020\_41834\_45068.jpg

Sign post on LS toe.

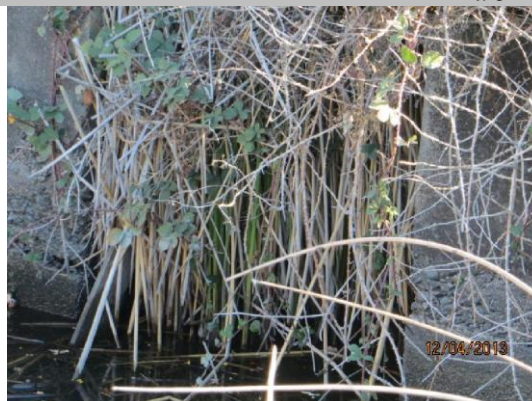
Photo 2 of 3 : UCIP\_SP\_2020\_24992\_45050.jpg

Vegetation covering possible location for 4X4 concrete culvert at LS toe.

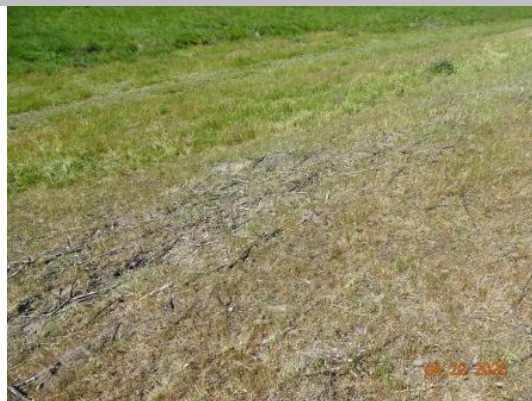
Photo 1 of 1 : SP\_2020\_RD2104\_249\_15\_20200423\_00057.jpg

LM Start	3.77	Rating **	M	Issue No.	15
LM End	3.84	Issue Type +	Ma	Location *	LS
Category	Earthen Levee			GPS Latitude/Longitude	
				Start	End
Item	Animal Control			38.307888 °	38.308483 °
				-121.734589 °	-121.735712 °
DWR ID	DWR_RD2104_01_s_2020_15				
Comment Code					
A2 : Repair the levee slope damaged by livestock and prevent large animal access.					
Inspector Comment					
Cows digging into levee.

View looking upstream at terracing due to cows in the landside slope (Spring 2020).

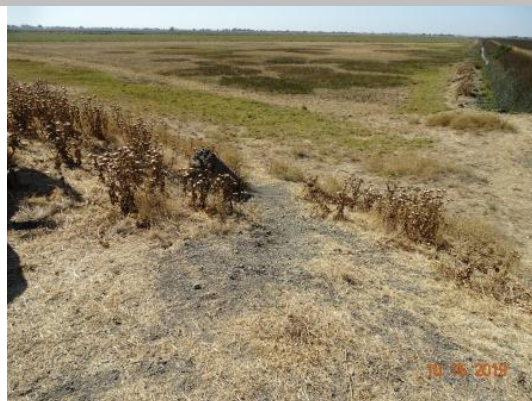
Photo 1 of 1 : SP\_2020\_RD2104\_249\_21\_20200304\_00004.jpg

LM Start	4.00	Rating **	M	Issue No.	21
LM End	4.00	Issue Type +	Ma	Location *	LS
Category	Earthen Levee			GPS Latitude/Longitude	
				Start	End
Item	Animal Control			38.310672 °	38.310672 °
				-121.736155 °	-121.736155 °
DWR ID	DWR_RD2104_01_f_2018_21				
Comment Code					
A2 : Repair the levee slope damaged by livestock and prevent large animal access.					
Inspector Comment					
There is a cow path on the landside slope.

View looking downslope at cow path on the landside slope (Fall 2019).

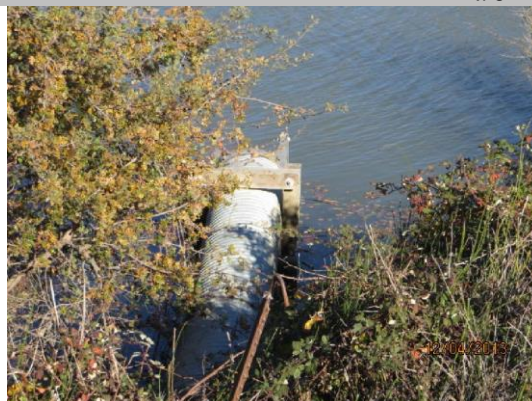
Photo 1 of 3 : UCIP\_SP\_2020\_51459\_45062.jpg

DS\_ID:24705  
FS\_ID:51459  
EP\_NO: 10182  
Repair Type: Non-Urgent  
Crossing Status: Found  
UCIP Comments: 12/06/2016 Crossing has been downgraded from "Urgent" to "Non-Urgent" no signs of leaks observed along pipe alignment (limited inspection on WS toe). According to LMA representative, this crossing was replaced 6 years ago (2010) at WS concrete apron. Recommend conducting internal inspection of pipe through the levee and LS to determine pipe integrity. (O. Magana - DWR UCIP)12/04/2013 Vegetation and soil buildup throughout pipe preventing flapgate from closing. Remove vegetation to allow gate to close properly. (W. Wylie - DWR UCIP)  
FIELD\_STRUCT\_DESC: 24-inch corrugated metal drainage pipe through the levee, 15 feet below the crown. 36-inch concrete standpipe on the landside (LS) toe. Flap gate on the waterside (WS) toe. Two corrugated metal cutoff walls installed. (24-inch pipe [HLM 4.65] authorized under Automatic Board Order (ABO) issued as Permit No. 10182, 1974 - Julia Trust Machado). [Additional Reference(s): DWR Levee Log, 2006. USACE Sacramento O&M Manual 108, April 1964, (HLM 4.65), Drawing No. 50-04-3379].

CMP pipe and flapgate off WS toe.

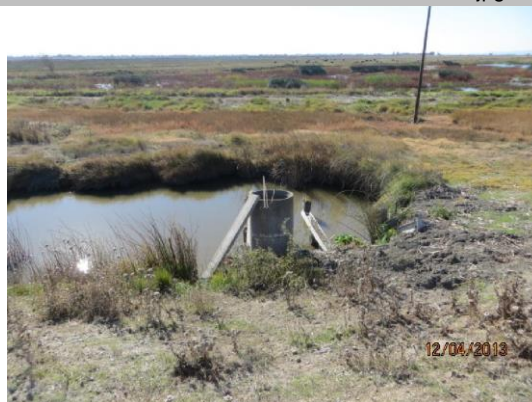
Photo 2 of 3 : UCIP\_SP\_2020\_51459\_45061.jpg

36-inch concrete riser on LS toe at channel.

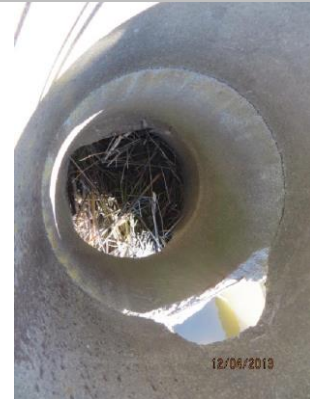
Photo 3 of 3 : UCIP\_SP\_2020\_51459\_45060.jpg

36-inch concrete riser with vegetation buildup inside.

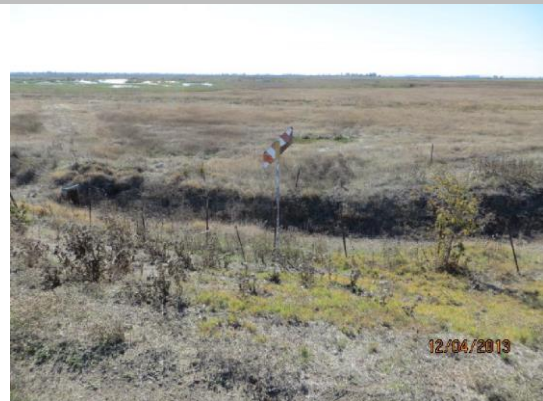
Photo 1 of 2 : UCIP\_SP\_2020\_25003\_45081.jpg

DS\_ID:24704  
 FS\_ID:25003  
 EP\_NO: 10182  
 Repair Type: Non-Urgent  
 Crossing Status: Found  
 UCIP Comments: Sign on WS toe needs repair.  
 FIELD\_STRUCT\_DESC: 8-inch steel gas line through the levee, at the high elevation. Signs on both toes of the levee. (Automatic Board Order (ABO) issued as Permit No. 10182, 1974 - Julia Trust Machado).  
 [Additional Reference(s): DWR Levee Log, 2006. USACE Sacramento O&M Manual 108, April 1964, Drawing No. 50-04-3379].  
 FS Date: 12/4/2013

Gasline marker on LS toe.

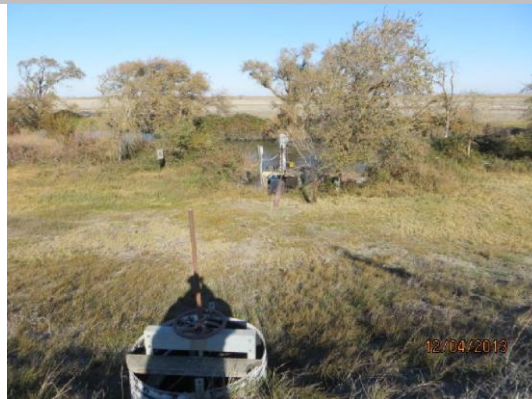
Photo 2 of 2 : UCIP\_SP\_2020\_25005\_45082.jpg

Slide gate in CMP riser on WS slope with pump on pier in background.

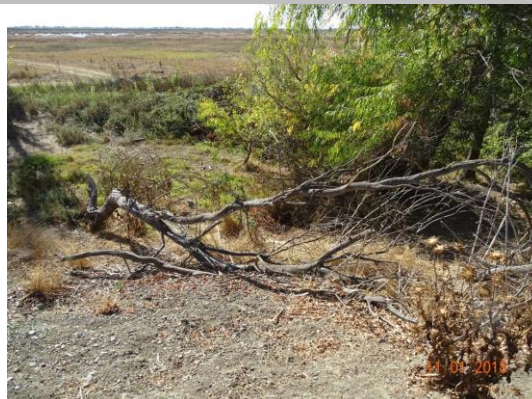
Photo 1 of 1 : SP\_2020\_RD2104\_249\_31\_20200304\_00008.jpg

LM Start	4.71	Rating **	M	Issue No.	31
LM End	4.71	Issue Type +	Ma	Location *	LS
Category	Earthen Levee			GPS Latitude/Longitude	
				Start	End
Item	Encroachments			38.318407 °	38.318407 °
				-121.744495 °	-121.744495 °
DWR ID	DWR_RD2104_01_f _ 2018_31				
Comment Code					
TR : Tree or limb					
Inspector Comment					
Remove tree limb on landside slope.

View of down tree limb on the landside slope (November 2018).

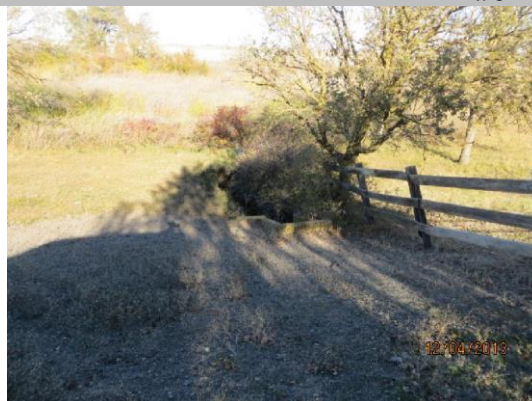
Photo 1 of 3 : UCIP\_SP\_2020\_25006\_45086.jpg

LM Start	4.72	Rating **	M	Issue No.	64	
LM End	4.72	Issue Type +	En	Location *		
Category	Supplemental			GPS Latitude/Longitude		
				Start		End
Item	DWR UCIP Field Study			38.318432 °	38.318432 °	
				-121.744540 °	-121.744540 °	
DWR ID	24702					
Comment Code						
Inspector Comment						
DS_ID:24702 FS_ID:25006 EP_NO: 10182 Repair Type: Non-Urgent Crossing Status: Found UCIP Comments: Minor erosion of base under headwall on WS toe. Heavy corrosion of pipe at WS toe. Further evaluation of pipe integrity needed. FIELD_STRUCT_DESC: 24-inch corrugated metal drainage pipe through the levee, 13.5 feet below the crown. Concrete U-shaped headwalls on both ends. Two corrugated metal cutoff walls. Flap gate on the waterside (WS) end. (Automatic Board Order (ABO) issued as Permit No. 10182, 1974 - Julia Trust Machado). [Additional Reference(s): DWR Levee Log, 2006]. FS Date: 12/4/2013

Concrete U shaped headwall on WS toe.

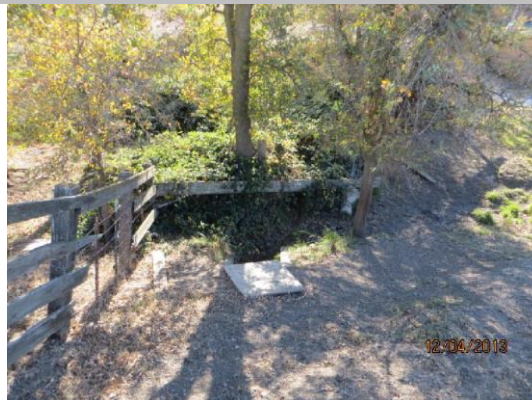
Photo 2 of 3 : UCIP\_SP\_2020\_25006\_45085.jpg

Concrete U shaped headwall on LS toe.

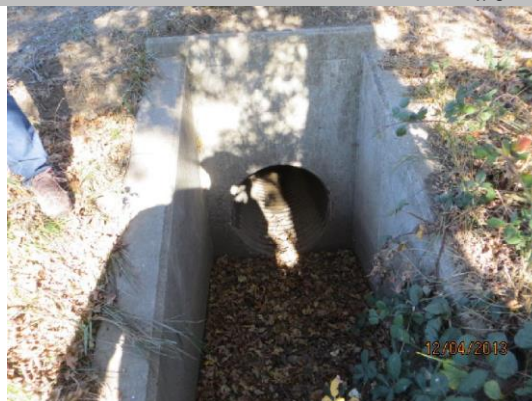
Photo 3 of 3 : UCIP\_SP\_2020\_25006\_45084.jpg

Concrete U shaped headwall on LS toe.

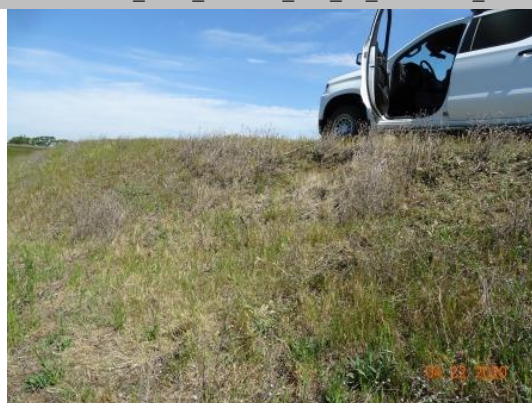
Photo 1 of 1 : SP\_2020\_RD2104\_249\_24\_20200423\_00058.jpg

LM Start	4.96	Rating **	M	Issue No.	24
LM End	4.96	Issue Type +	Ma	Location *	LS
Category	Earthen Levee			GPS Latitude/Longitude	
				Start	End
Item	Slope Stability			38.320382 °	38.320382 °
				-121.748155 °	-121.748155 °
DWR ID	DWR_RD2104_01_f_2017_24				
Comment Code					
S1 : Repair slope instability.					
Inspector Comment

View looking upstream slope instability at the landside hinge (Spring 2020).

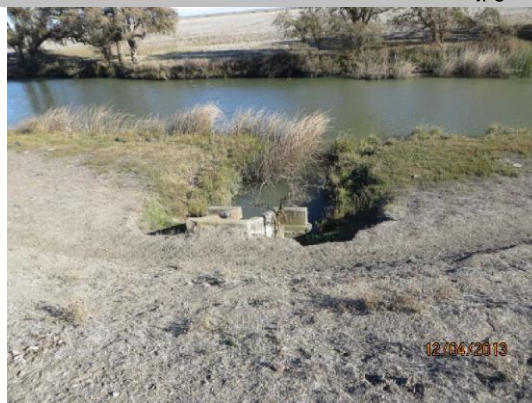
Photo 1 of 3 : UCIP\_SP\_2020\_53387\_45090.jpg

Comment Code						
Inspector Comment						
DS_ID:24701 FS_ID:53387 EP_NO: 10182 Repair Type: Urgent Crossing Status: Found UCIP Comments: 10/12/2018 Same as last inspection; concrete headwall on WS still being undermined so crossing remains Urgent (D. Sanoski - DWR UCIP).12/06/2016 same as last inspection--pipe remains "Urgent" CMP shows holes through wall and concrete headwall is undermined. Need to contact owner. Owner will need to work with the CVFPB to comply with Title 23. (O. Magana - DWR UCIP)12/04/2013 Footing under headwall on WS toe severely undermined. Pipe rusted heavily with holes at WS and may need replacement. (W. Wylie - DWR UCIP) FIELD_STRUCT_DESC: 24-inch corrugated metal drainage pipe through the levee, 13 feet below the crown. Two cutoff walls. Concrete U-shaped headwalls on both ends. Flap gate on the waterside (WS). (24-inch pipe [HLM 5.50] authorized under Automatic Board Order (ABO) issued as Permit No. 10182, 1974 - Julia Trust Machado). [Additional Reference(s): DWR Levee Log, 2006. USACE Sacramento O&M Manual 108, April 1964, (HLM 5.5), listed as a 12-inch pipe, Drawing No. 50-04-3379, listed as an 18-inch pipe]. FS Date: 10/12/2018 5:06:00 PM

Concrete U-shaped headwall on WS toe. Note erosion scarp around headwall.

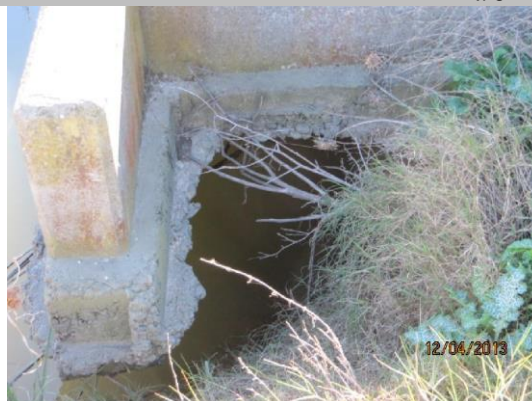
Photo 2 of 3 : UCIP\_SP\_2020\_53387\_45089.jpg

Headwall undermined on WS toe.

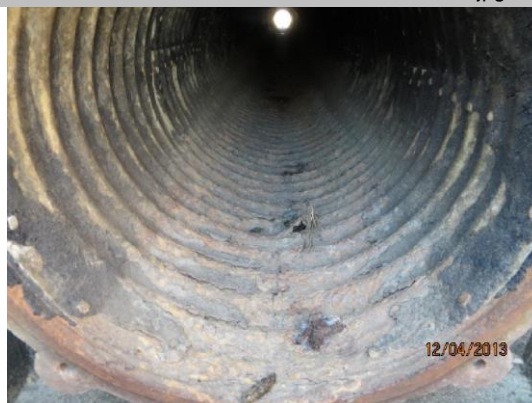
Photo 3 of 3 : UCIP\_SP\_2020\_53387\_45088.jpg

LM Start	<b>5.09</b>	Rating **	U	Issue No.	<b>65 (cont)</b>
LM End	<b>5.09</b>	Issue Type +	Ma	Location *

Corrosion through pipe with holes on WS toe.

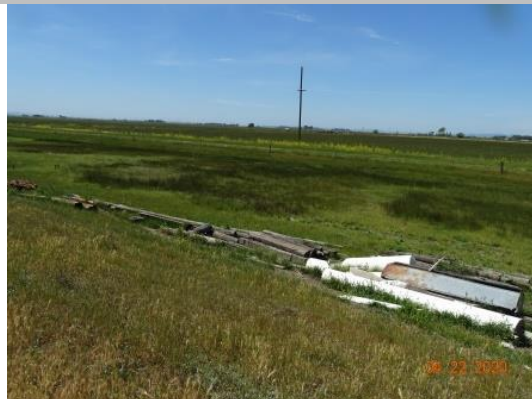
Photo 1 of 1 : SP\_2020\_RD2104\_249\_39\_20200423\_00059.jpg

View looking upstream at debris on the waterside toe (Spring 2020).

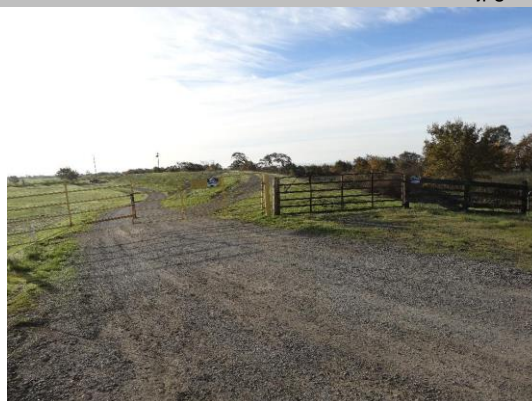
Photo 2 of 3 : UCIP\_SP\_2020\_53385\_76914.jpg

No signs present of gas line.

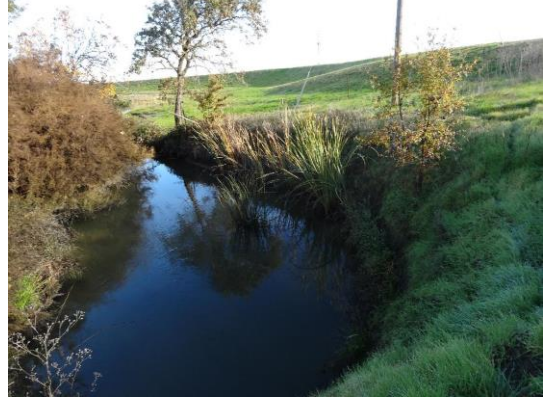
Photo 3 of 3 : UCIP\_SP\_2020\_53385\_76915.jpg

Photo of where the line is estimated to cross on LS.
